COLD SPRING DAM (UPPER)

PUTNAM COUNTY, NEW YORK

INVENTORY NO. N.Y. 106

PHASE I INSPECTION REPORT  
NATIONAL DAM SAFETY PROGRAM.

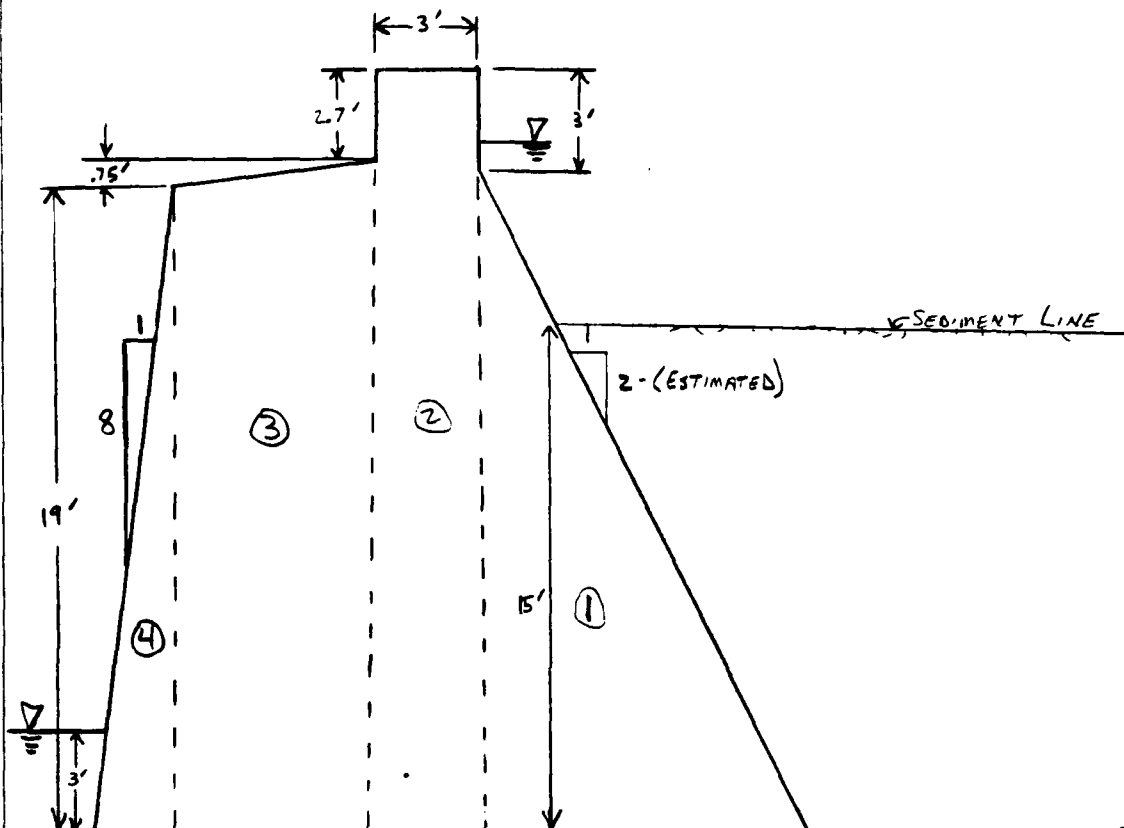
SECTION FOR  
STABILITY ANALYSIS

The analyses indicates that the factors of safety for overturning and sliding are below recommended values for all conditions studied. The safety factors against sliding fall to critical levels when subjected to ice loading or the depth of overtopping resulting from either the PMF or 1/2 the PMF.

Analysis was based on approximate cross section, shown on following page, developed from measurements made at the time of inspection. A normal analysis was performed, including an overturning analysis, since the dam has a composite cross section consisting of both concrete and laid-up stone. Due to unknown foundation conditions, full uplift was assumed at the upstream toe, decreasing to the tail-water pressure at the downstream toe.

Further investigations are required to better assess the stability of the dam. Subsurface explorations are required to obtain information about the foundation material and the uplift forces. Accurate cross sections of the dam should also be obtained. Stability analyses should then be performed using this data. Based on the results of these analyses, required modifications to the structure should be made.
